Pitting and intergranular corrosion

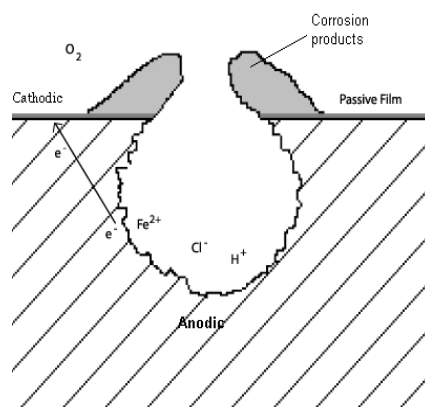
- Pitting corrosion is extremely localized corrosion that leads to the formation of small holes in the metal.
- A small area of pit or hole becomes anode while the other large area becomes cathode.
- Pitting can be takes place due to a small surface defect or scratch or damage to the protective coating.
- A single pit can cause large damage.

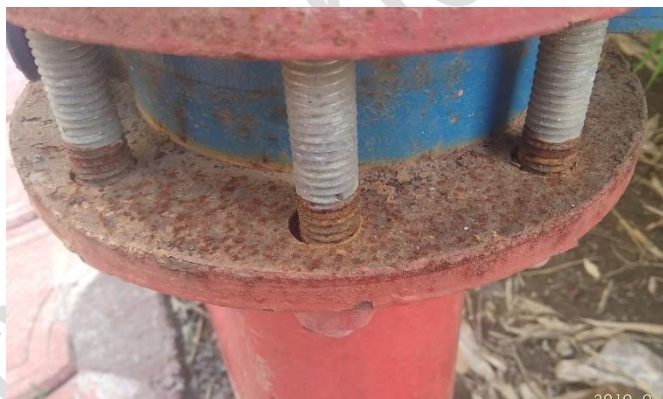
Actual example of Pitting corrosion

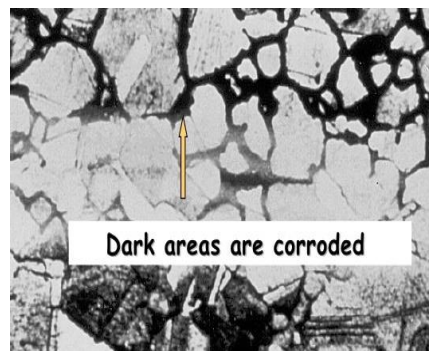
- This corrosion observed where the boundaries of crystallites of the material are more susceptible to corrosion than their insides.
- In the presence of tensile stress, cracking may occur along grain boundaries.
- It is observed in the case of weld decay.

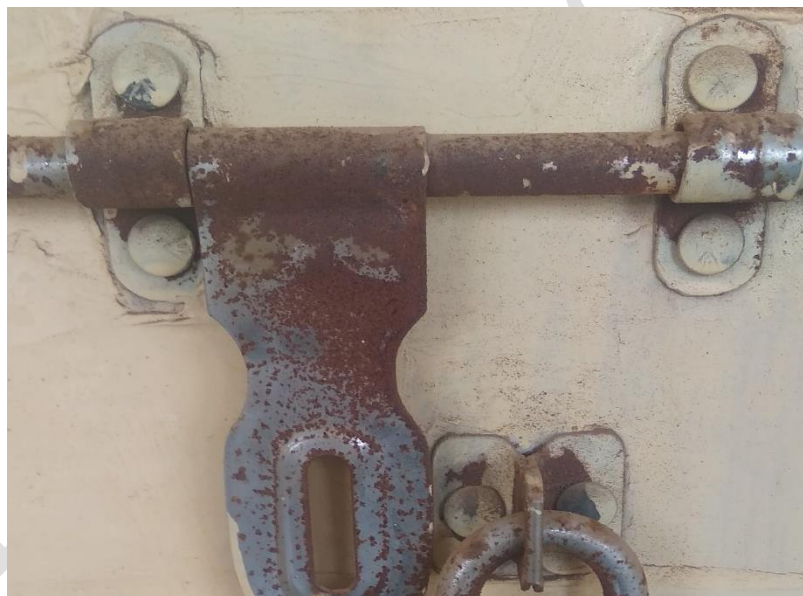
Actual example of intergranular corrosion
